The Ephraim Public Library is a Carnegie library with a central downtown location. Exterior brick has been painted. The exterior shows some signs of wear and water damage – peeling paint, cracks, spalled concrete, chipped stone, rusted metal, and missing or patched mortar. A second pane of clear glass has been installed outside historic windows; in one area windows have been replaced with clear double-paned windows in aluminum sash. One of the original exterior lights at the entry is missing its glass globe.

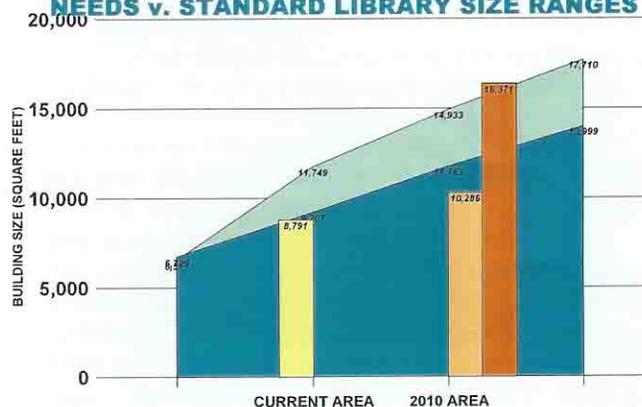
## NEEDS v. STANDARD LIBRARY SIZE RANGES

- BENCHMARKS BASED ON ANTICIPATED 2010 SERVICE POPULATION
- BENCHMARKS BASED ON CURRENT SERVICE POPULATION
- EXISTING AREA (SQ FT)
- EXISTING AREA x GROWTH FACTOR
- EXISTING AREA x GROWTH FACTOR + ADDITIONAL FUNCTIONS

ITEM	AREA (square feet)
Existing library area	8,791
Space for additional functional needs	6,085
Space to meet projected growth (growth factor x current area)	1,495
<b>TOTAL</b>	<b>16,371</b>
